TOWN OF DENTON STORMWATER INVENTORY

JULY 2022

Town of Denton Stormwater Inventory

Prepared by the
Piedmont Triad Regional Council

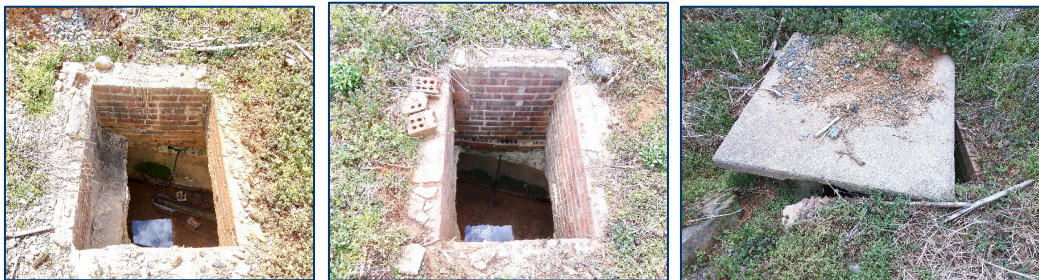
Three catchbasins, two missing covers, at former Burlington Industries, along Bombay St.

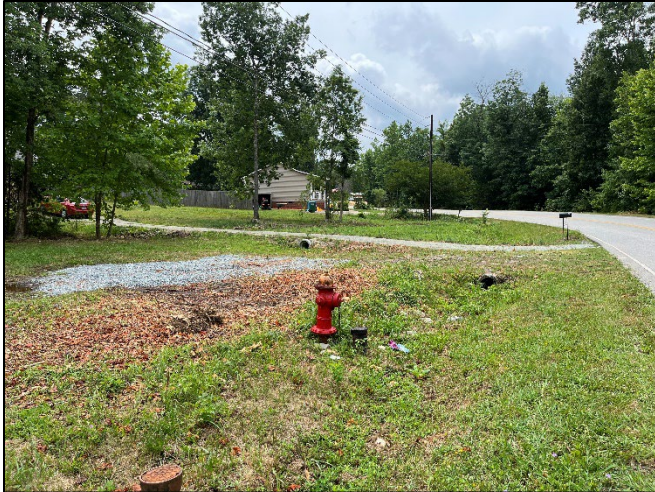
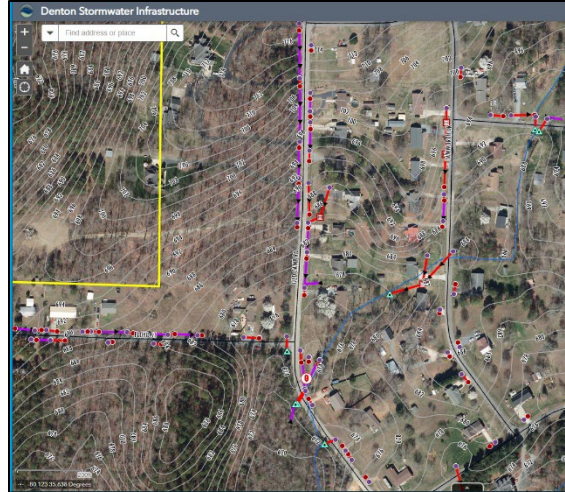
Clark Acres at Old Camp Road: Road is pitched; three different inlet pipes lead to three open channelized areas, draining to Old Camp Road; Map image on right shows elevation change to the corner of Old Camp Road.

As noted in Area #2-West Denton the area along Old Camp Road has issues with the stormwater that flows down the road, floods the house at this bend, it is the low spot collecting water upstream before it heads back under Old Camp Road. PTRC staff observed several channelized ditches and/or gulleys that converge in front of house. It was observed to have standing water in the one ditch and it was observed that the corrugated metal pipe is blocked with debris and garbage. This has been noted as an area as having historic flooding, stormwater issues. It is recommended that a professional engineering firm be engaged in order to further assess how the movement of stormwater flows in this area. A first step would be to conduct some pipe maintenance and clean-outs so that the existing infrastructure can function, however a larger evaluation should occur here.

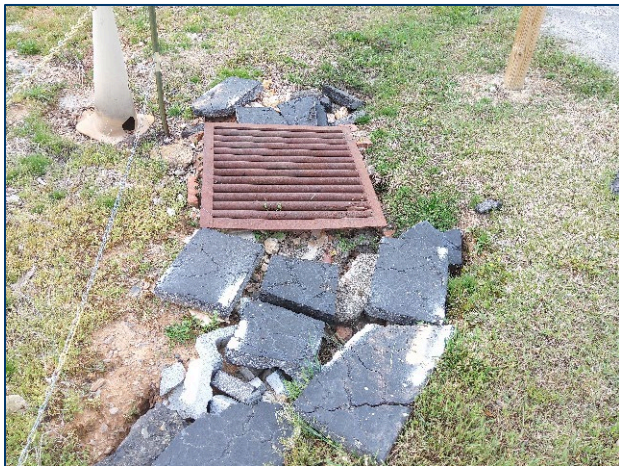
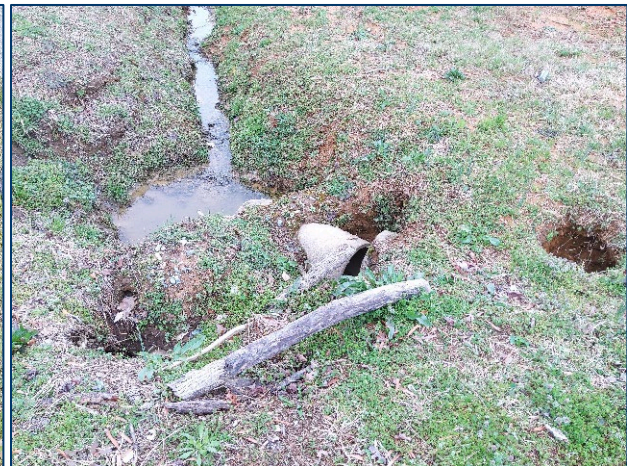
W. James to Anderson St.	Broken pieces of asphalt laying in area; flow of water coming from S. Main St., heading west.
S. Bingham St., Bell Ave, parking lot behind Town Hall	Ground caving in above structure, filled in and hap hazardly covered with asphalt blocks; major safety issue

*(Left) Safety issue - broken asphalt with unsecured grate placed on top
 (Right) Exposed pipes and sinkholes, evidence of surface and overland flow*

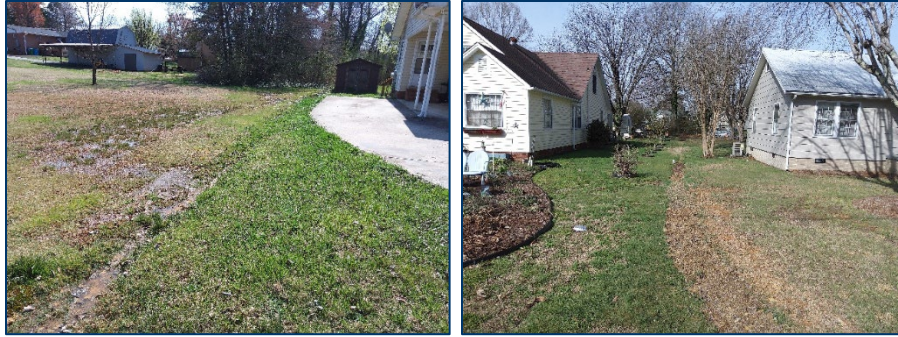
Potential Raingarden(s) on E Third and Spring St

As noted in Area #3, at the intersections of E. Third Street with both Spring St and Broad St, all downhill from NC Hwy 109 there were several areas of concern noted such as issues with standing water. This location could be an ideal candidate for rain garden(s), planting of native trees and/or installation of rain barrels to collect run-off from the area homes. There is evidence of water issues on paved areas/home lots off Spring St, with issues with standing water at E. Third, Spring and Broad St. as well as noted poor drainage. Further investigation for appropriately sized and sited SCMs would help to capture and treat stormwater runoff and prevent standing water/flooding issues. : standing water; broad, Third & spring street (block) (pic on left); (pic on right) issue with poor drainage, standing water in between houses: roadway floods- see wet signature on pavement between houses off Spring St.

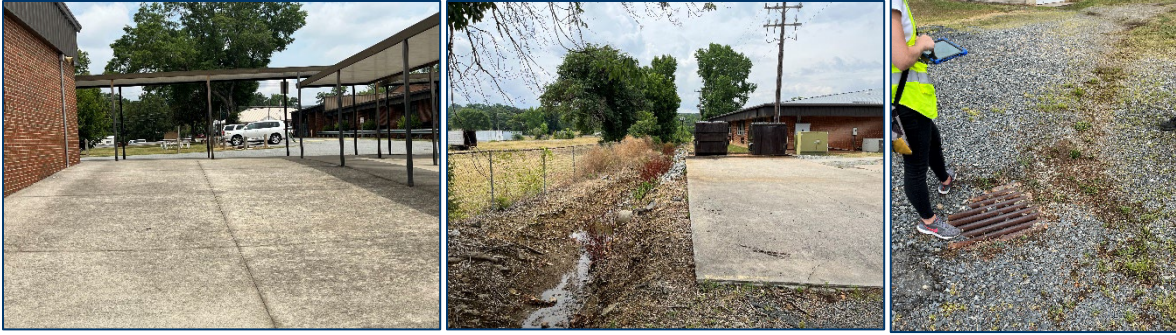
Noted in Area #3, the Denton Elementary School property goes from W. Salisbury Street, main school entrance, and slopes to W. Peacock Ave, back of the school, there is a 1,055 foot long drainage ditch on the school's eastern boundary with ball fields to the west. There are several noted issues dealing with flooding or stormwater along W. Peacock Ave. The property encompasses 17.54 acres. Based on field observations and conversations with the Davidson County Schools maintenance staff that is responsible for the maintenance at the Denton Elementary School, there has been historic flooding issues that have severely impacted the school, buildings and grounds area. It is suggested that further identification of issues of concern be identified and corresponding SCMs or BMPs to best tackle stormwater and flooding be explored with the Davidson County Schools. These type of locations could be ideal opportunities for grant funding as they could incorporate academic opportunities and hands-on applications to address aging or unmet stormwater needs.

School grounds contain lots of impervious surfaces, unvegetated drainage ditches, and unmanaged drainage areas

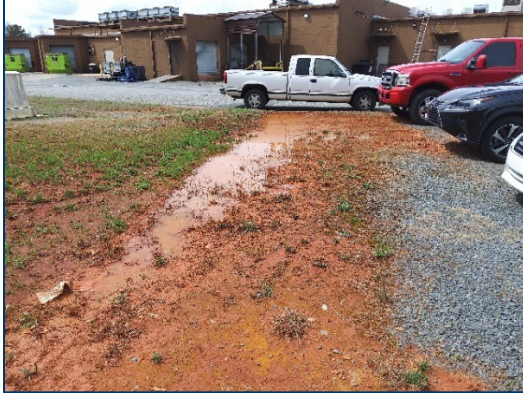
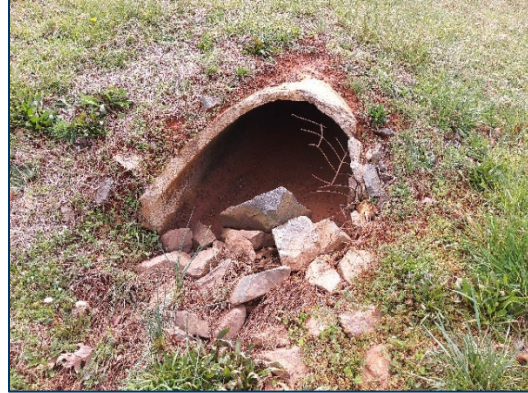
As identified in Area #4, at the Lowes Food of NC Hwy 109, there were identified issues with ponding water near and around the shopping center parking lot including areas behind the building as well as areas of concern at the nearby gravel parking area that is across from northern entrance to center. It is noted that pipe outlet #1126 needs repair or replacement. This area should be further inspected to identify areas that can be repaired as well as to identify areas most suitable to implement SCMs. A simple, yet effective practice would be to make sure that all exposed soil is covered in vegetation, it could simply be grasses, however native trees or shrubs would further enhance the infiltration process, reduce uncontrolled runoff and improve aesthetics of the center, both in the front and behind the building.

SCMs to reduce sediment, erosion; repair broken pipes
