City of Reidsville Senior Center Sidewalk Crossing Study

Final Report

PIEDMONT TRIAD
REGIONAL COUNCIL

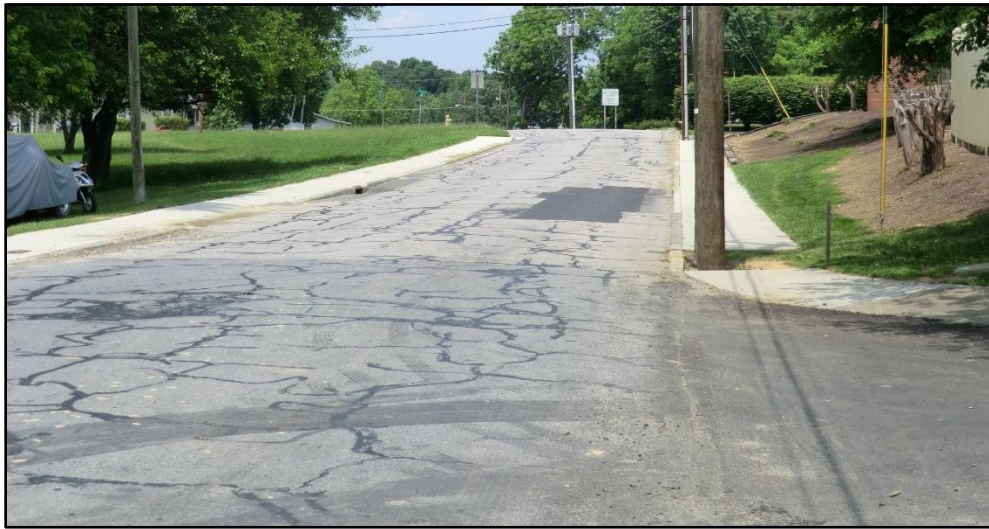
*Figure 1: Pavement Conditions on Washington Avenue
Looking North from Habitat Place*

The condition of the roadway can be generally described as fair to poor depending on location. The pavement has been repaired in several areas due to wear or utility work, however, there are signs of distress that still exist, as shown in the photo below (Figure 1).

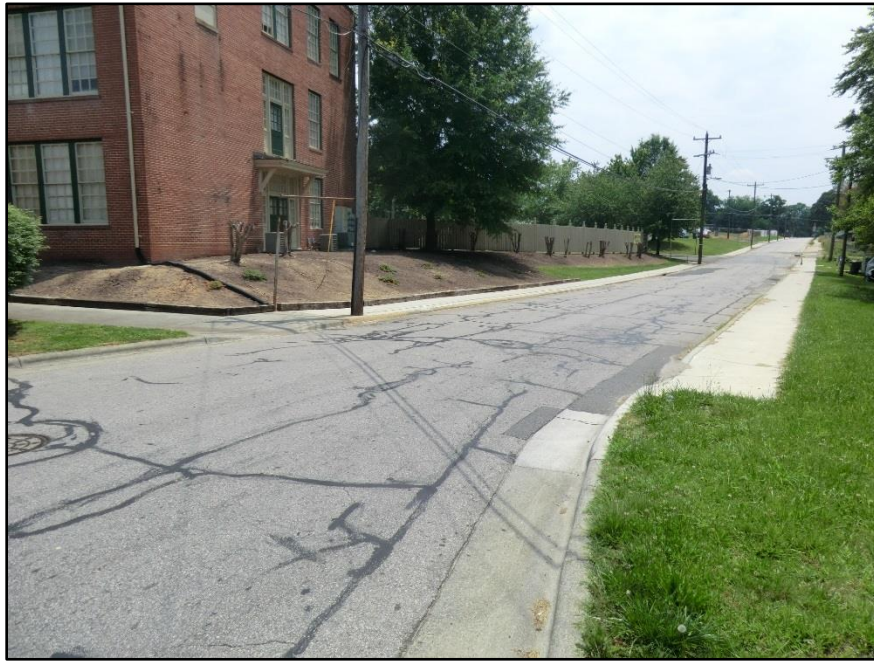
Figure 2: Location of Sidewalks Looking South Inside Study Area

Several yards of sidewalk exist on both sides of North Washington Street within the study area (see Figure 2). The condition of the sidewalks vary from good to poor depending on the location. However, the majority of sidewalks are considered to be in good condition due to upgrades in the past few years. The sidewalk access is continuous within the study area except for an approximately 9.5 foot gap near the corner of Washington Avenue and Habitat Place as seen in Figure 3, likely due to a utility pole replacement. The map in Figure 4 illustrates the location and condition of sidewalks in the study area and the location of curb ramps.

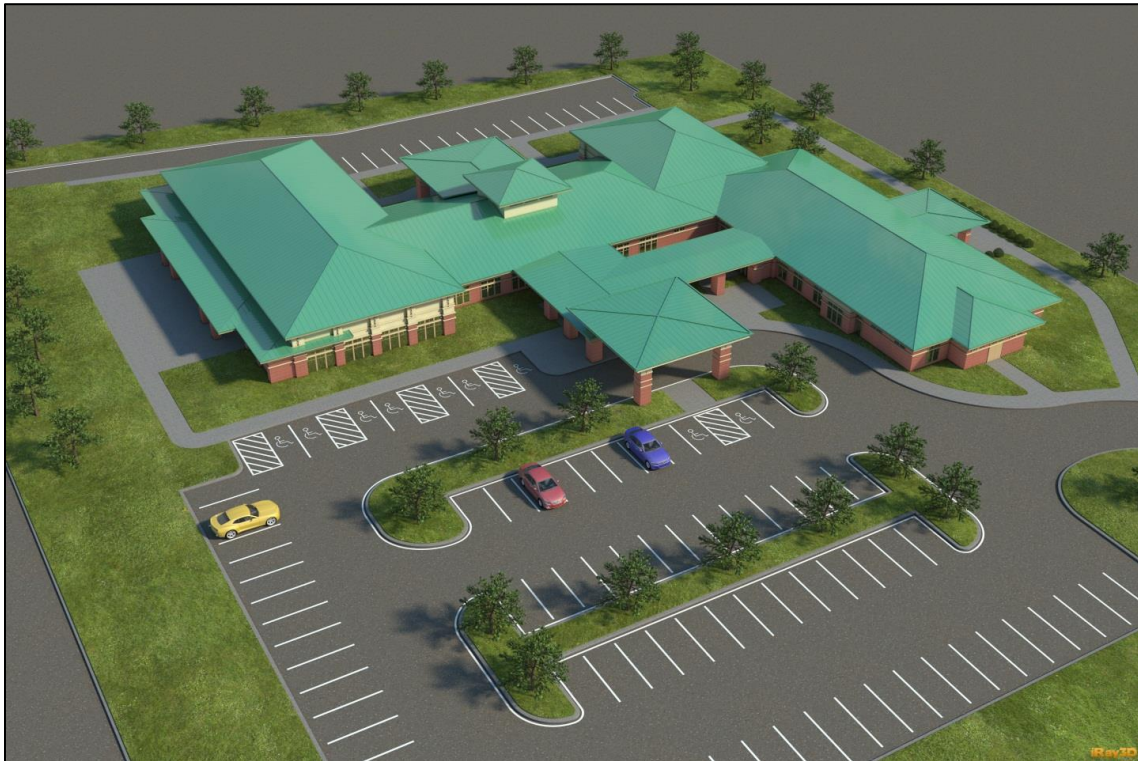
The Senior Center (see rendering in Figure 5), located at 102 North Washington Avenue, is approximately 500 feet to the south of the Recreation Administration/Gymnasium. According to information provided by The City of Reidsville, the new Senior Center building will include a multi-purpose gym, fitness room, dance theater, craft room, computer lab, library, social lounge and a large dining room. The remaining space will be used by Aging, Disability, and Transit Services (ADTS) of Rockingham County while the exterior of the facility will include parking for 100 vehicles; outdoor courts for shuffleboard, bocce ball, and horseshoes; decorative landscaping and a concrete sidewalk surrounding the entire grounds allowing a handicap (ADA) accessible pedestrian route.

Figure 5: 3D Rendering of New Senior Center

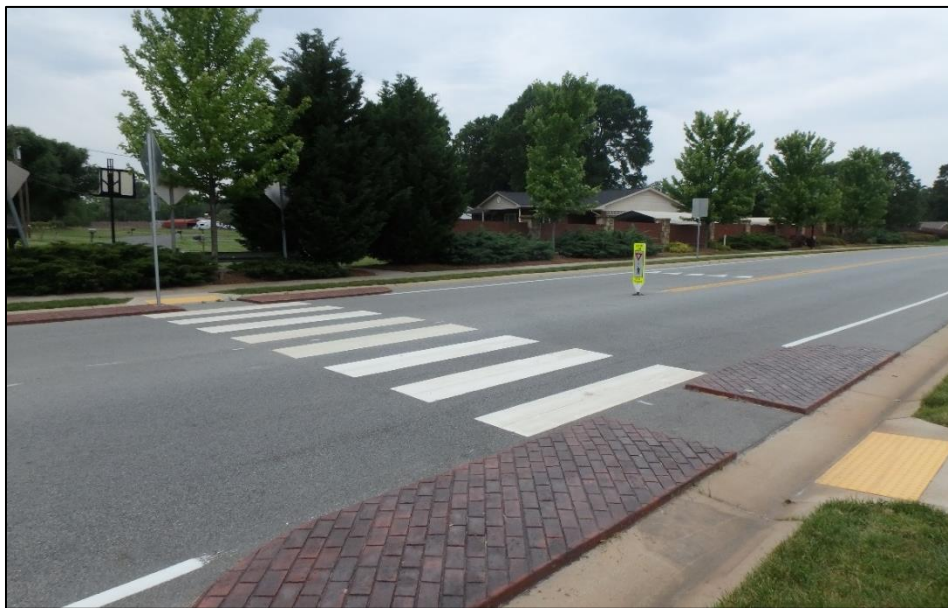
Figure 6: Unsignalized Mid-block Crossing Example in Kernersville, NC

To accommodate the expected rise in pedestrian traffic volume between the existing Parks and Recreation building and the new Senior Center, an ***unsignalized mid-block crossing on North Washington Street has been chosen as the desired pedestrian accommodation*** to connect the existing Parks and Recreation Facility with the new Senior Center. A pedestrian mid-block crossing is a marked crosswalk that occurs in a location other than an intersection. An example of an unsignalized mid-block crossing is shown in Figure 6. This crossing connects a neighborhood with a shopping district.

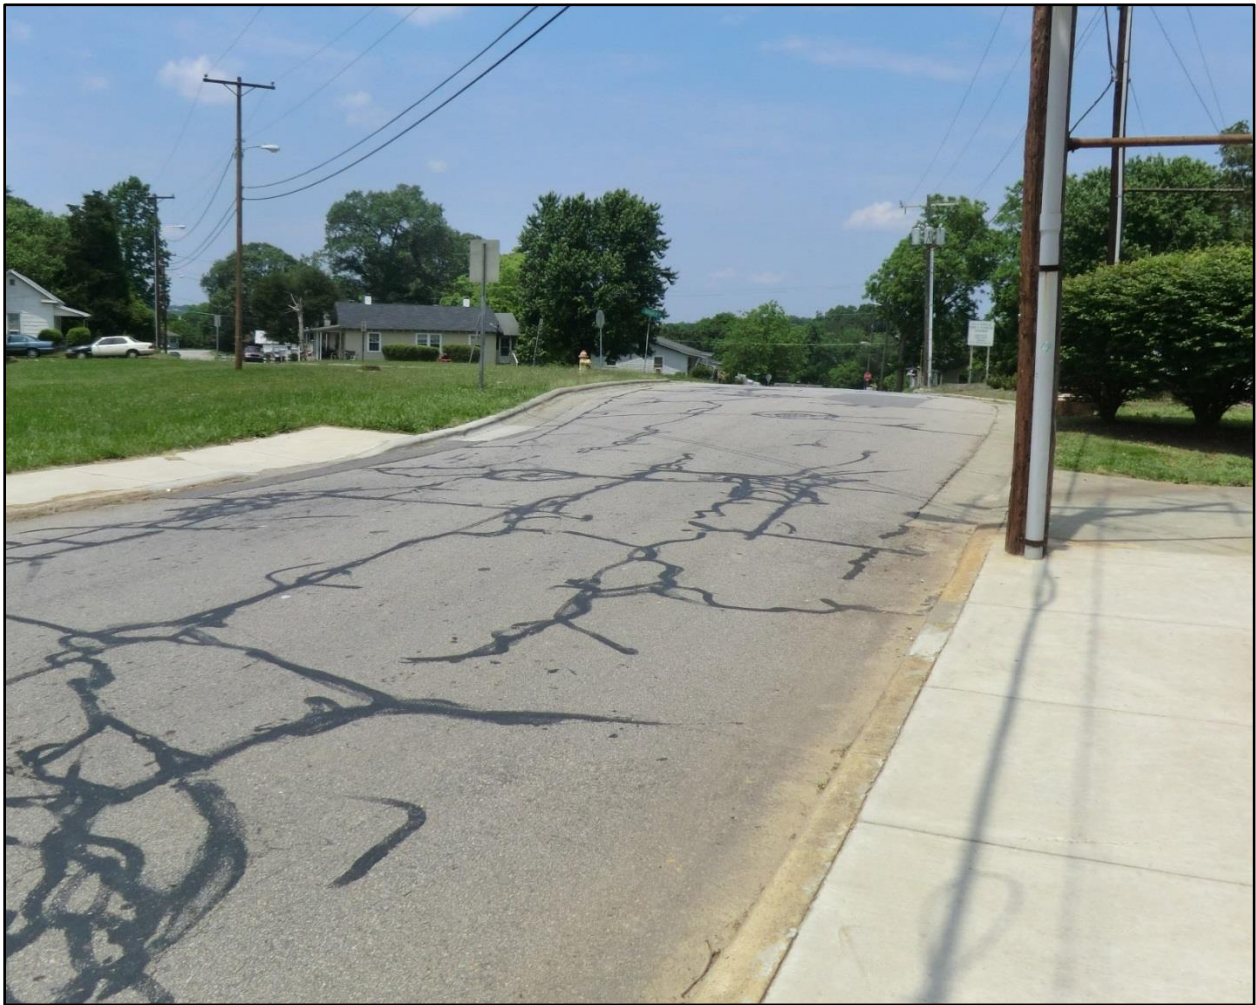
Figure 9: Crossing Location Before Midblock Crossing

The following is more detailed information regarding the types of signs and markings that are recommended for the unsignalized mid-block crossing on North Washington Street. These recommendations are for Option 3, but can be modified to fit other options if desired. Figure 9 and Figure 11 show before and after views of the midblock crossing and Figure 10 provides a summary of these recommendations.

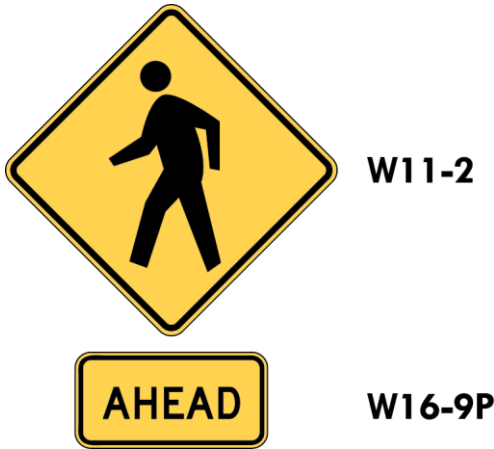
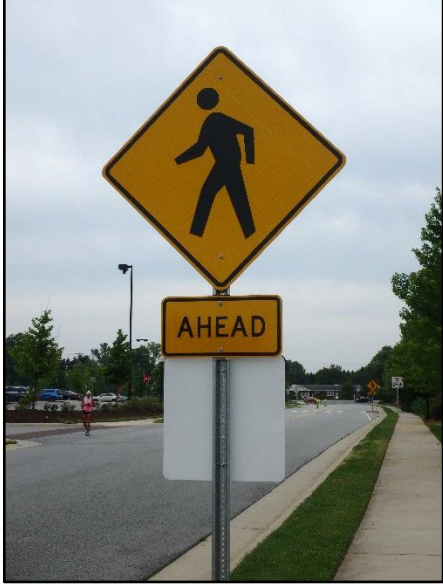
<p>Advance signing is used to provide additional notification to drivers that a crosswalk is near and pedestrians may be crossing the roadway. Advance signing is particularly useful at locations where a crosswalk might be unexpected by approaching drivers. (Source: TCRP Report 112/NCHRP Report 562)</p>

<p>MUTCD Description: Non-Vehicular Warning signs may be used to alert road users in advance of locations where unexpected entries into the roadway might occur or where shared use of the roadway by pedestrians, animals, or equestrians might occur. When used in advance of a pedestrian, snowmobile, or equestrian crossing, the signs should be supplemented with plaques with the legend AHEAD or XX FEET to inform road users that they are approaching a point where crossing activity might occur.</p>	<p>MUTCD Guidance: When a fluorescent yellow-green background is used, a systematic approach featuring one background color within a zone or area should be used. The mixing of standard yellow and fluorescent yellow-green backgrounds within a selected site area should be avoided. Non-vehicular signs should be used only at locations where the crossing activity is unexpected or at locations not readily apparent.</p>

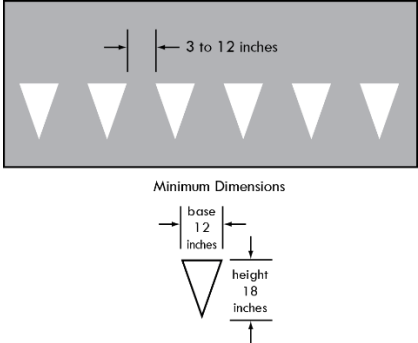
<p>At midblock crossings and signalized or stop-controlled approaches to intersections, the vehicle yield line can be moved farther back from the pedestrian crosswalk for an improved factor of safety and for improved visibility of pedestrians.</p>

<p>The diagram shows a series of white triangular advance yield lines on a road surface. The spacing between the lines is labeled as '3 to 12 inches'. Below the lines, a 'Minimum Dimensions' diagram shows a single triangle with a 'base 12 inches' and a 'height 18 inches'.</p>

<p>FHWA Ped Facilities Users Guide Description: Advance yield lines allow pedestrians and drivers to have a clearer view of each other and more time in which to assess intentions. The effectiveness of this tool depends upon whether motorists are likely to obey the stop line, which varies. In some places, the yield line has been moved back by 15 to 30 feet (4.6 to 9.1 m) relative to the marked crosswalk with considerable safety benefits for pedestrians.</p>	<p>MUTCD Guidance: If used, yield lines should be placed a minimum of 4 feet (1.2 m) in advance of the nearest crosswalk line at controlled intersections. If used at an un-signalized midblock crosswalk, yield lines should be placed adjacent to the Yield Here to Pedestrian sign located 20 to 50 feet (6.1 to 15 m) in advance of the nearest crosswalk line, and parking should be prohibited in the area between the yield line and the crosswalk.</p>

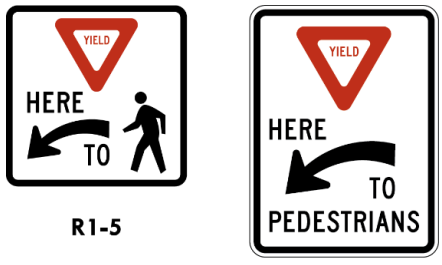
<p>Two signs are shown. Sign R1-5 is a square sign with a red inverted triangle at the top containing the word 'YIELD'. Below it, the text 'HERE TO' is on the left and a pedestrian icon is on the right, with a curved arrow pointing from the text to the icon. Sign R1-5a is similar but the text below the triangle reads 'HERE TO PEDESTRIANS'.</p>

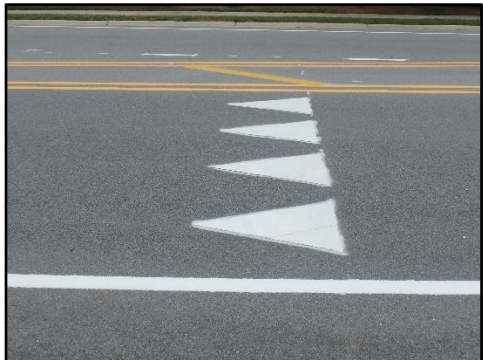
<p>A photograph showing a road with a white advance yield line consisting of several triangles pointing towards the driver, positioned before a crosswalk.</p>

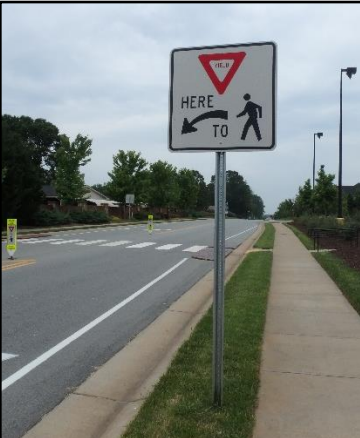
<p>A photograph of a 'Yield Here to Pedestrians' sign (R1-5a) mounted on a post at the side of a road near a crosswalk.</p>

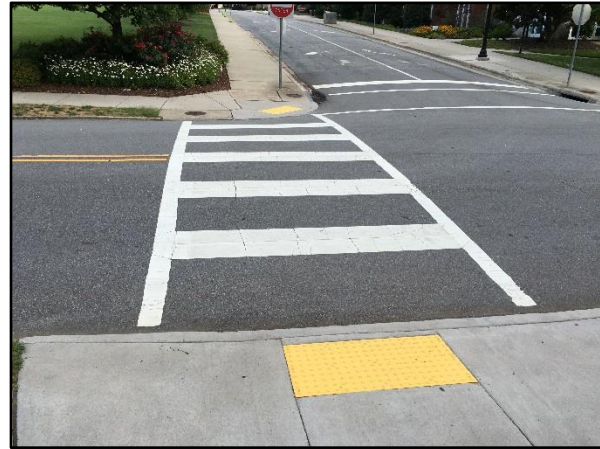
Markings provide guidance for pedestrians who are crossing roadways by defining and delineating paths on approaches to and within signalized intersections, and on approaches to other intersections where traffic stops. They also alert road users of a pedestrian crossing point across roadways not controlled by signals or stop signs. At non-intersection locations, markings legally establish the crosswalk. Specific guidance on the use of marked crosswalks is provided in FHWA-RD-01-075. These FHWA guidelines may be used as a supplement to the guidelines for marked crosswalks presented here. (Source: TCRP Report 112/NCHRP Report 562)

MUTCD Markings Guidance: Crosswalks should be no less than 6 feet (1.8 m) wide. Crosswalk lines should extend across the full width of pavement. Crosswalks should be marked at all intersections with “substantial conflict” between vehicles and pedestrians.

MUTCD Markings Standard: When crosswalk lines are used, they shall consist of solid white lines that shall not be less than 6 in nor greater than 24 in wide.

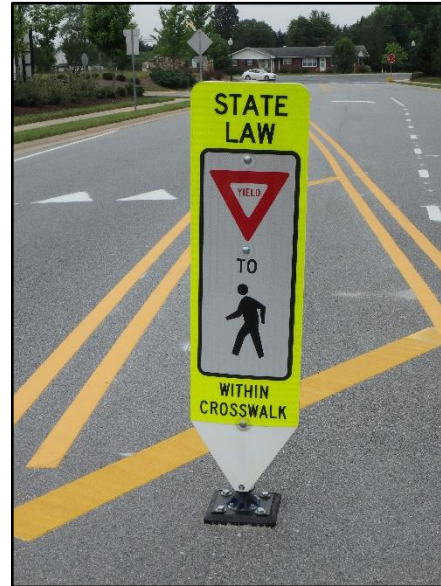
R1-6

The In-Street Pedestrian Crossing sign (R1-6 or R1-6a) may be used to remind road users of laws regarding right of way at an un-signalized pedestrian crossing. The legend STATE LAW may be shown at the top of the sign if applicable. The legends STOP FOR or YIELD TO may be used in conjunction with the appropriate symbol. (Source: TCRP Report 112/NCHRP Report 562)

MUTCD Standard: The In-Street Pedestrian Crossing sign shall not be used at signalized locations. The STOP FOR legend shall only be used in states where the state law specifically requires that a driver must stop for a pedestrian in a crosswalk. If used, the In-Street Pedestrian Crossing sign shall have a black legend (except for the red STOP or YIELD sign symbols) and border on either a white and/or fluorescent yellow-green background. If the In-Street Pedestrian Crossing sign is placed in the roadway, the sign support shall comply with the breakaway requirements of the latest edition of AASHTO's specifications.

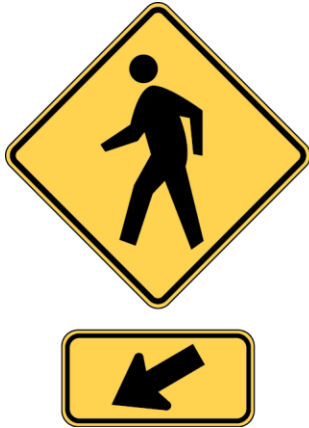
Pedestrian crossing signs (W11-2 and W16-7P) may be used to alert road users in advance of locations where unexpected entries into the roadway or shared use of the roadway by pedestrians may occur.

MUTCD Signs Guidance: When used in advance of a crossing, the W11-2 sign may have a supplemental plaque with the legend AHEAD or XX FEET to provide advance notice to road users of crossing activity.

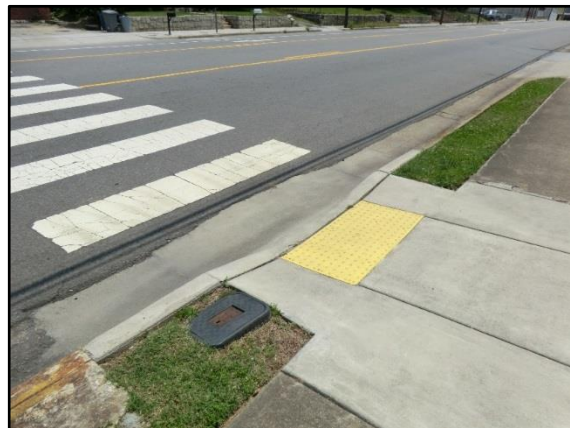
Detectable warnings are a distinctive surface pattern of domes detectable by cane or underfoot that alert people with vision impairments of their approach to street crossings and hazardous drop-offs. They are used to indicate the boundary between pedestrian and vehicular routes where there is a flush instead of a curbed connection. (Source: United States Access Board)

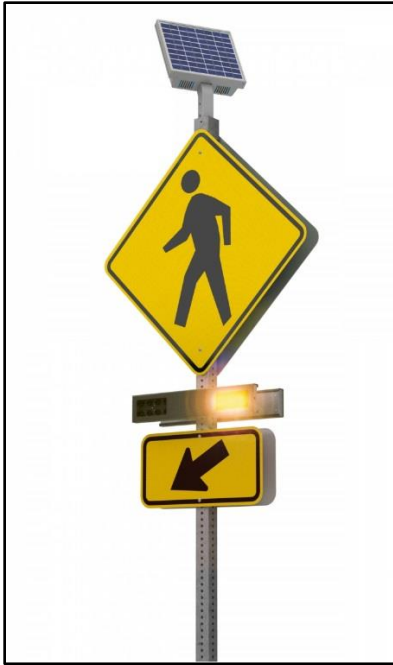
RRFBs are user-actuated amber LEDs that supplement warning signs at un-signalized intersections or mid-block crosswalks. They can be activated by pedestrians manually by a push button or passively by a pedestrian detection system. RRFBs use an irregular flash pattern that is similar to emergency flashers on police vehicles. RRFBs may be installed on either two-lane or multi-lane roadways. (Source: http://safety.fhwa.dot.gov/intersection/conventional/unsignalized/tech_sum/fhwasa09009)

The RRFB design differs from the standard flashing beacon by utilizing: A rapid flashing frequency (approximately 190 times per minute), a brighter light intensity, and ability to aim the LED lighting.
