TOWN OF DENTON STORMWATER INVENTORY

JULY 2022

Town of Denton Stormwater Inventory

Prepared by the
Piedmont Triad Regional Council

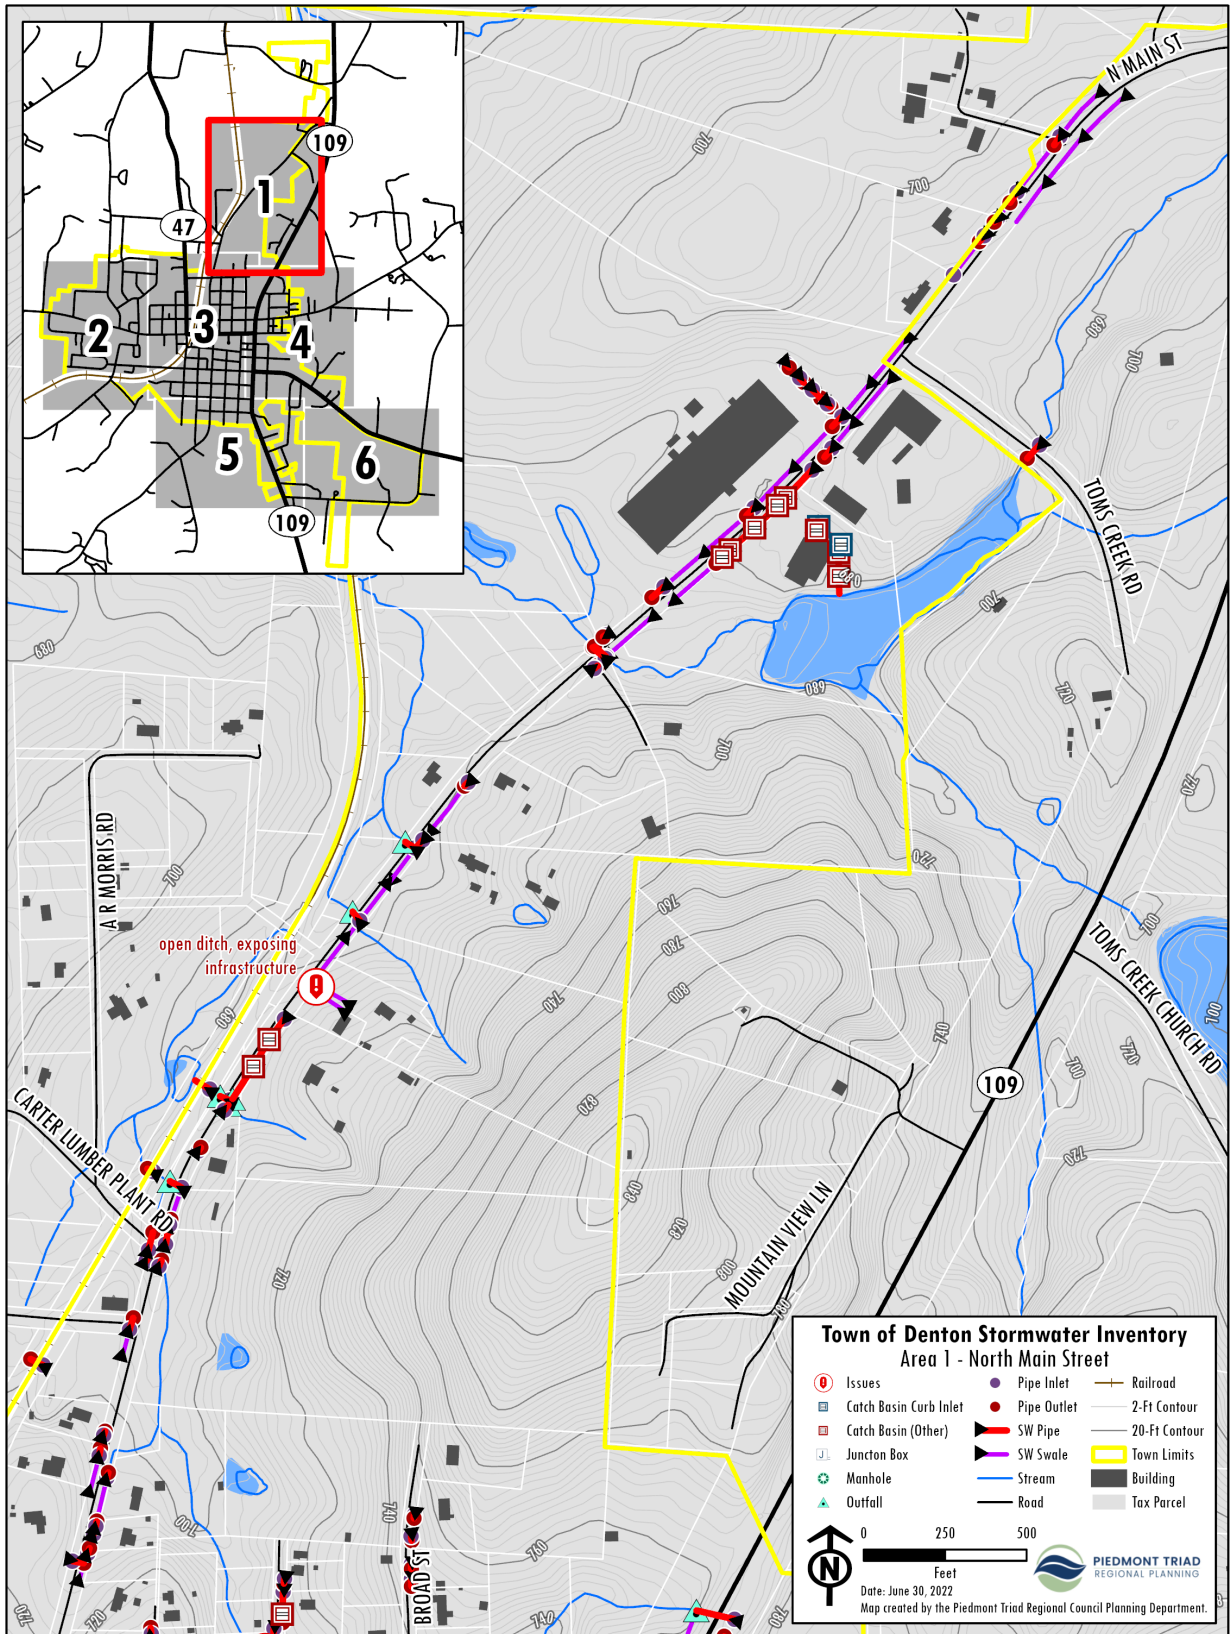
Map 7: Area #1 – North Main Street

Stormwater Infrastructure Issues	
Location	Description
N. Main St, 1,193 feet north of Carter Davis Rd., on eastern side of N. Main St.,	Open ditch/channel; exposed soil, stagned water; corrugated HDPE pipe under driveway; area prime for SCM, along driveway and along N. Main St.; ideal location for linear rain garden or planted channel/ditch; would need to check overhead utilities
End of Broad and Spring St.	Future location of new construction, Tower Mountain. Proposed 46 homes; 6 off N. Main St, drainage will flow towards N. Main St. Encourage enhanced stormwater control measures and/or use of green infrastructure in new building area
Health & Safety Issues	
Location	Description
Off N. Main St.	Open ditch, exposing infrastructure; along gravel drive, #794 N Main St.

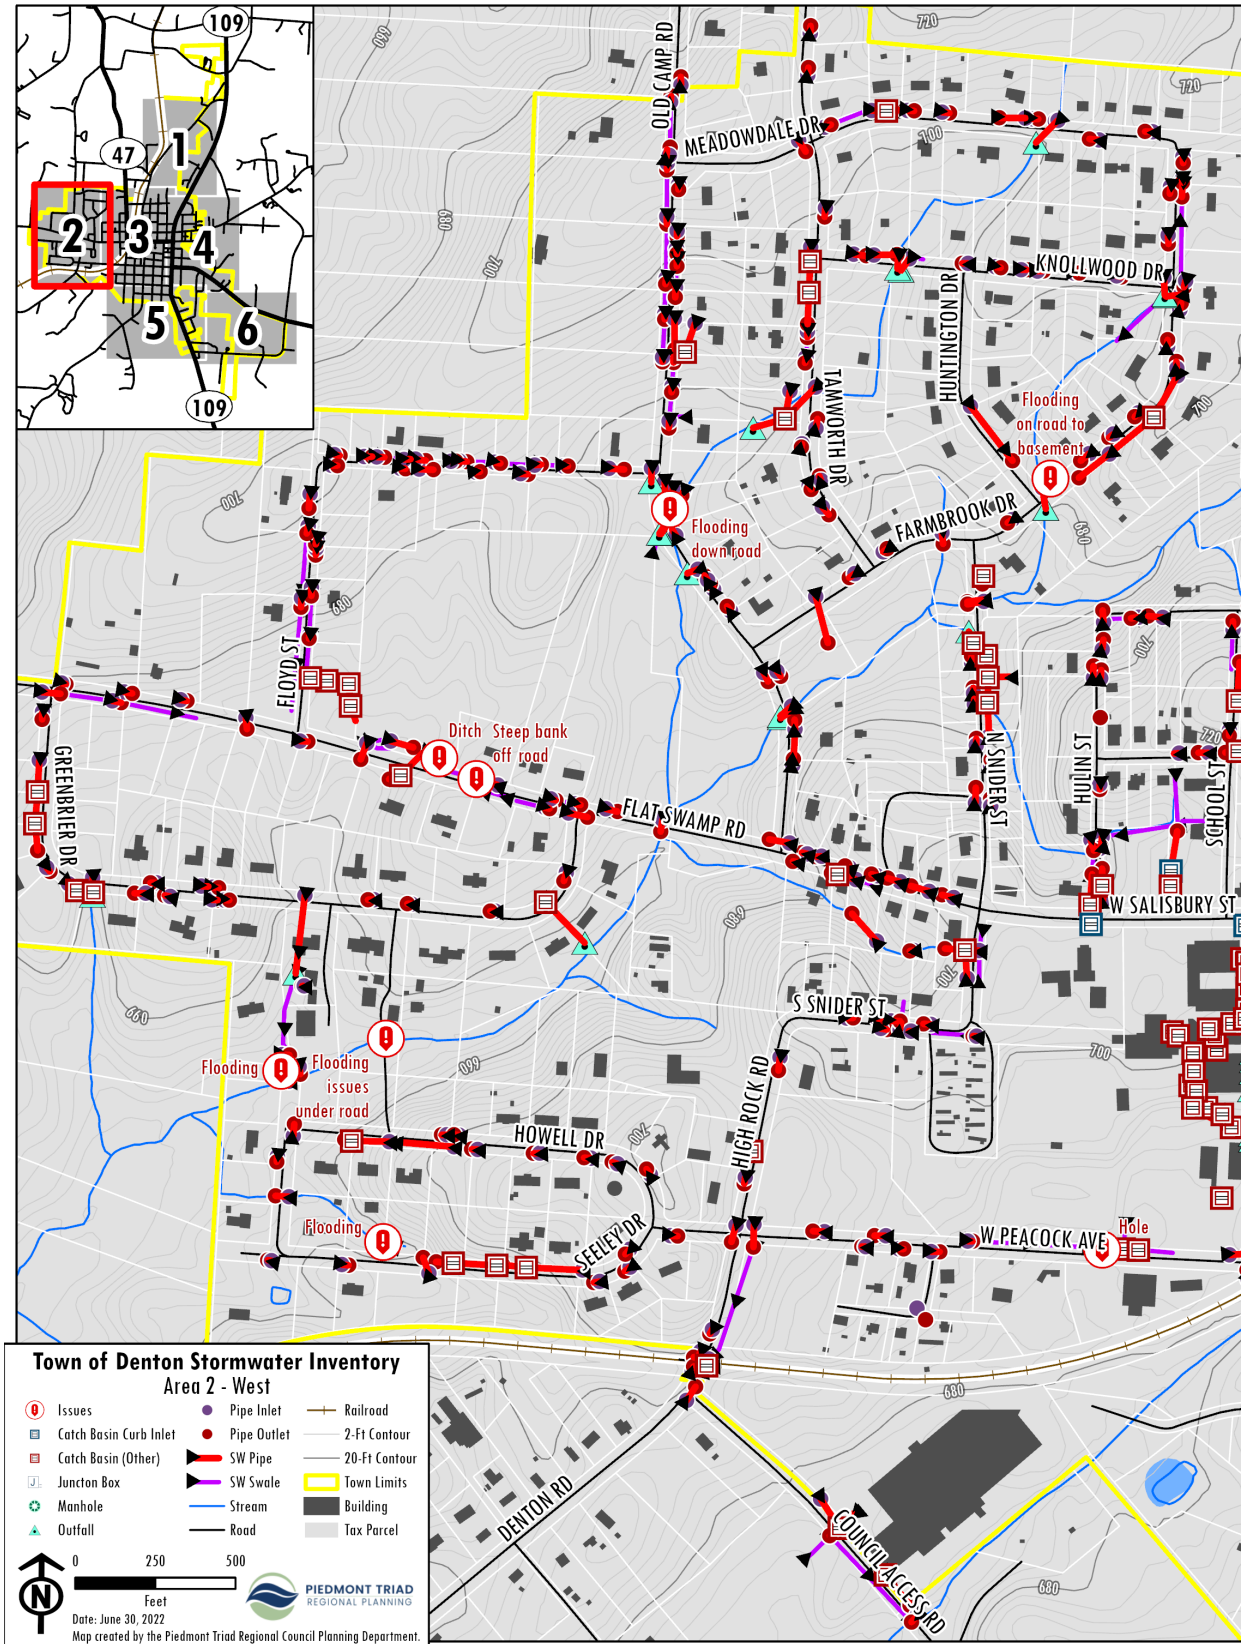
Map 8: Area #2 – West Denton

Stormwater Infrastructure Issues	
Location	Description
Clarks Acres: Corner of Farmbrook Rd & Huntington Dr	Homeowner noted flooding up to basement door; flooding on road. Based on mapping, tributary appears it turns in this section, right behind homeowners pool; there is an approximate 6-foot elevation drop behind house to water course; recommend buffer, improve infiltration from house, reduce the large amount of impervious surface
Clarks Acres * Off Old Camp Road, south of Floyd St	Water comes down road, floods house, road is banked so water cannot get over road; multiple channelized/gulleys in front of house; 3 deep ditches with standing water in it; corrugated metal pipe blocked with debris & garbage Upstream (up Old Camp rd) pipes blocked or filled in with grass, sediment House sits in low spot where pipes collect runoff and goes under road
Greenbriar Dr.; rural homesite	Flooding issues, no buffer on either side, a few trees here and there Plant buffer along tributary (Lick Creek)

Drive way off Wynona Ln/south of Greenbriar Dr.	Newly installed culvert under lane, however it is noted: “still floods”; rural area where slope comes down to Lick Creek trib on both sides Suggestion: investigate wooded area; add, improve infiltration here, based on mapping, the elevation above indicates this area is downhill and water flows in that direction
Seeley Dr.	Homeowner indicated flooding when rain heavy; 22ft elevation drop; leading to Lick Creek trib (headwaters); driveway culvert
Corner bend in S. Snider St. & High Rock Rd.	Logging/grading at/near headwaters of Lick Creek trib

W. Peacock Ave	Noted visual issues; holes, pipe sections disconnected from each other Could be ideal location for linear rain garden along W. Peacock Ave ditch, approximately 746 feet from Denton Elementary School
Health & Safety Issues	
Location	Description
Swale, off Flat Swamp Road; 340 feet west of Greenbrier Rd; east of Floyd St.	Noted while in field: homeowner wants to fill in, deep embankment, feels safety issue if car goes off road Issue: acting as swale to convey water away from houses, off roadway. Investigate water flow in this area, based on topography. Suggest: alternative to “filling” it in; suggest step, pool, linear rain garden if no utility conflicts
Ditch, off Flat Swamp Road; approx. 459 feet west of Greenbrier Rd; east of Floyd St; off road approx. 32 feet	Appears as if swale as noted above drains to this ditch; without any infrastructure to further direct flow; does it drain into the wooded area in this block

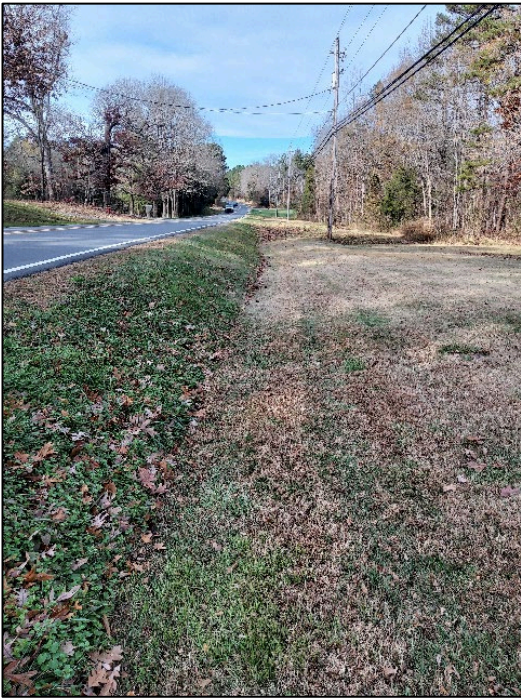
Clark Acres at Old Camp Road: Road is pitched; three different inlet pipes lead to three open channelized areas, draining to Old Camp Road; Map image on right shows elevation change to the corner of Old Camp Road.

As noted in Area #2-West Denton the area along Old Camp Road has issues with the stormwater that flows down the road, floods the house at this bend, it is the low spot collecting water upstream before it heads back under Old Camp Road. PTRC staff observed several channelized ditches and/or gulleys that converge in front of house. It was observed to have standing water in the one ditch and it was observed that the corrugated metal pipe is blocked with debris and garbage. This has been noted as an area as having historic flooding, stormwater issues. It is recommended that a professional engineering firm be engaged in order to further assess how the movement of stormwater flows in this area. A first step would be to conduct some pipe maintenance and clean-outs so that the existing infrastructure can function, however a larger evaluation should occur here.

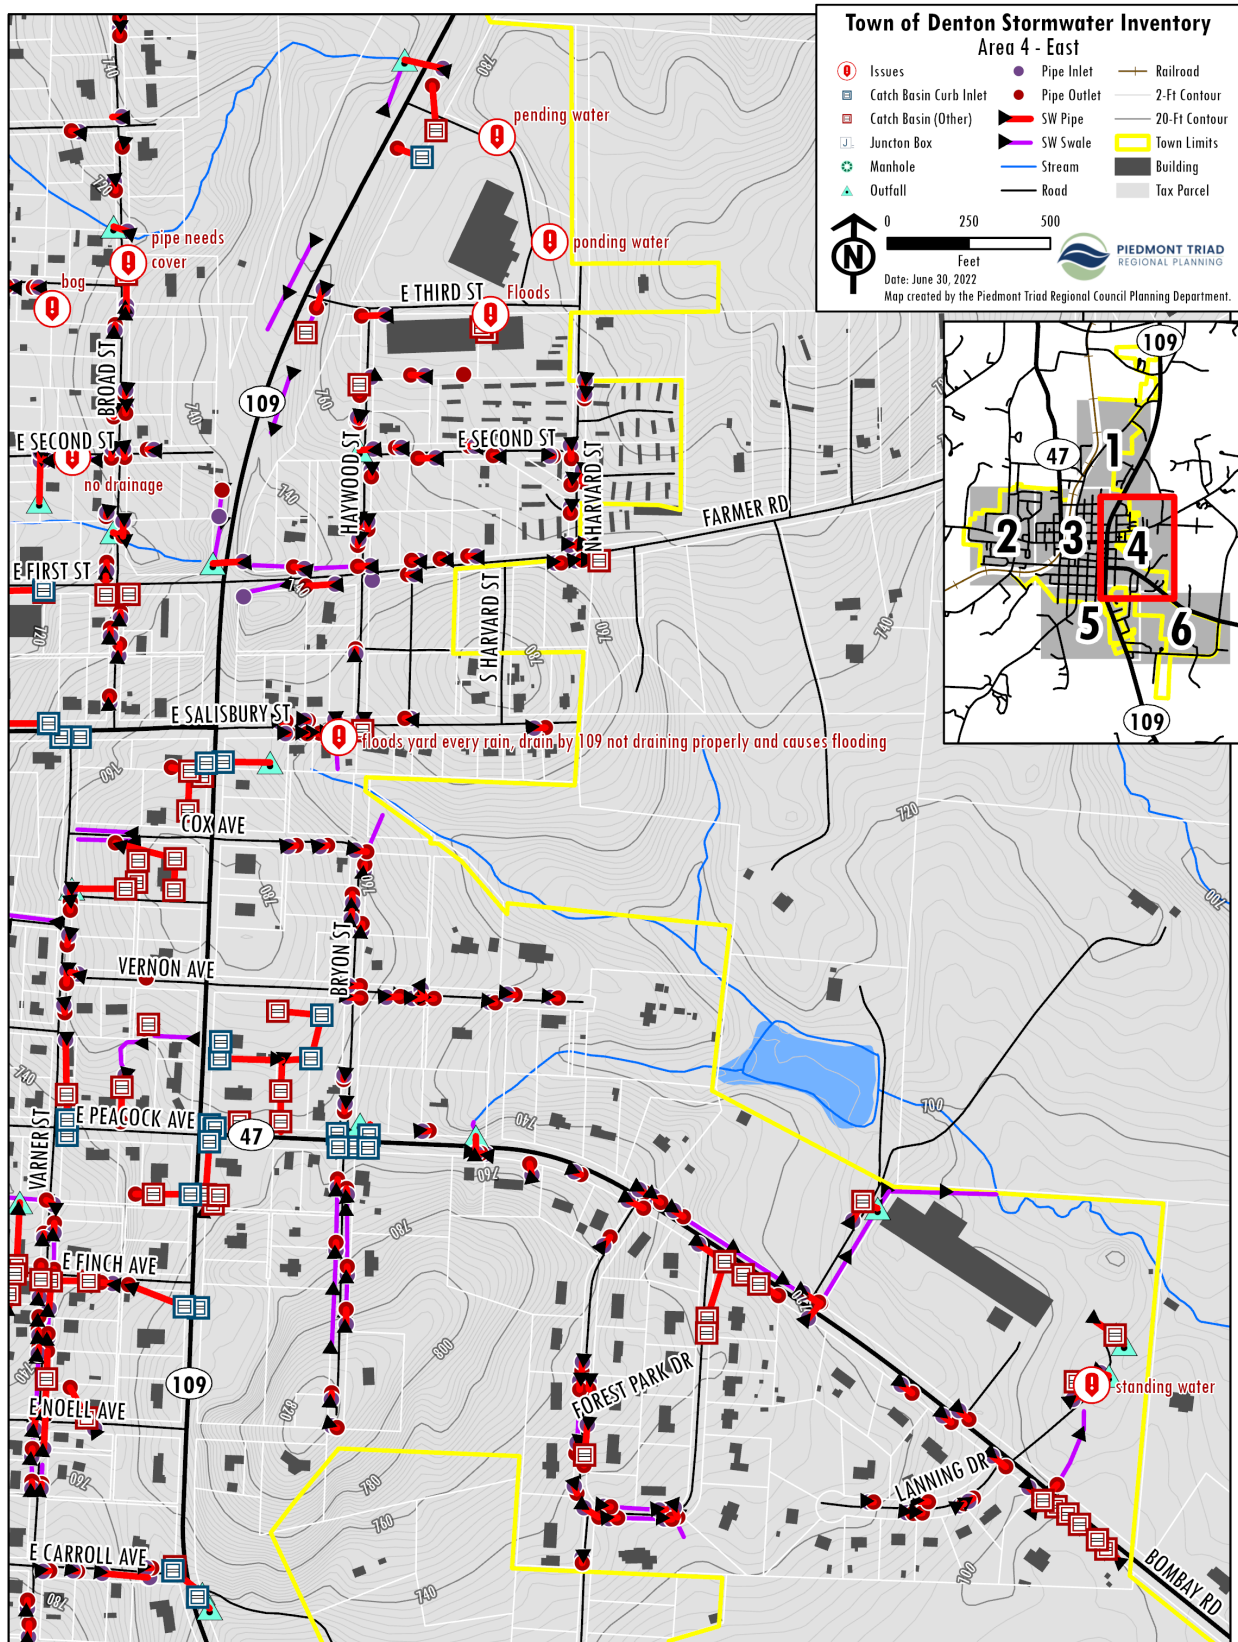
Map 10: Area #4 – East Denton

Stormwater Infrastructure Issues	
Location	Description
Across from Denton Cementary-E. Salisbury & Haywood St.	Home sits in bowl
Block/Property surrounded by E. Peacock Ave (to south), Varner St.(to west), Vernon Ave (to north); Glenn St./NC109 (to east);	(Backyard Buildings & Creations) noted from field visit, owner put in own pipe; inlet is concreted in with surrounding land/slope concreted like a funnel to the pipe #755; 151 foot swale leading to inlet pipe, swale goes around structures/grassy area
Off Bombay, Access lane across from Lanning Dr.; eastern edge of town (near wooded area)	Standing water; area driveway culverts (#630, #676, #767) and catch basin (#5133) are full of leaf litter and/or filled in; gravel; no where for water to flow, ponding in front of pipes
*E. Third St.(to north), Haywood St. (to west); N. Harvard St. (to east)	Noted as floods; commerical buildings with driveway/access between in lower spot; goes from 778 ft to 772 through access lane; area contains 2 catch basins; 1 inlet, 1 outlet- made of PVC

S. Bingham St.; edge of parking lot behind Town Hall	CB #5282; brick wall is bowing out, appears to be caving in
Health & Safety Issues	
Location	Description
Broad St. (approx. 67 feet north of E. Third St.)	Open pipe, needs cover

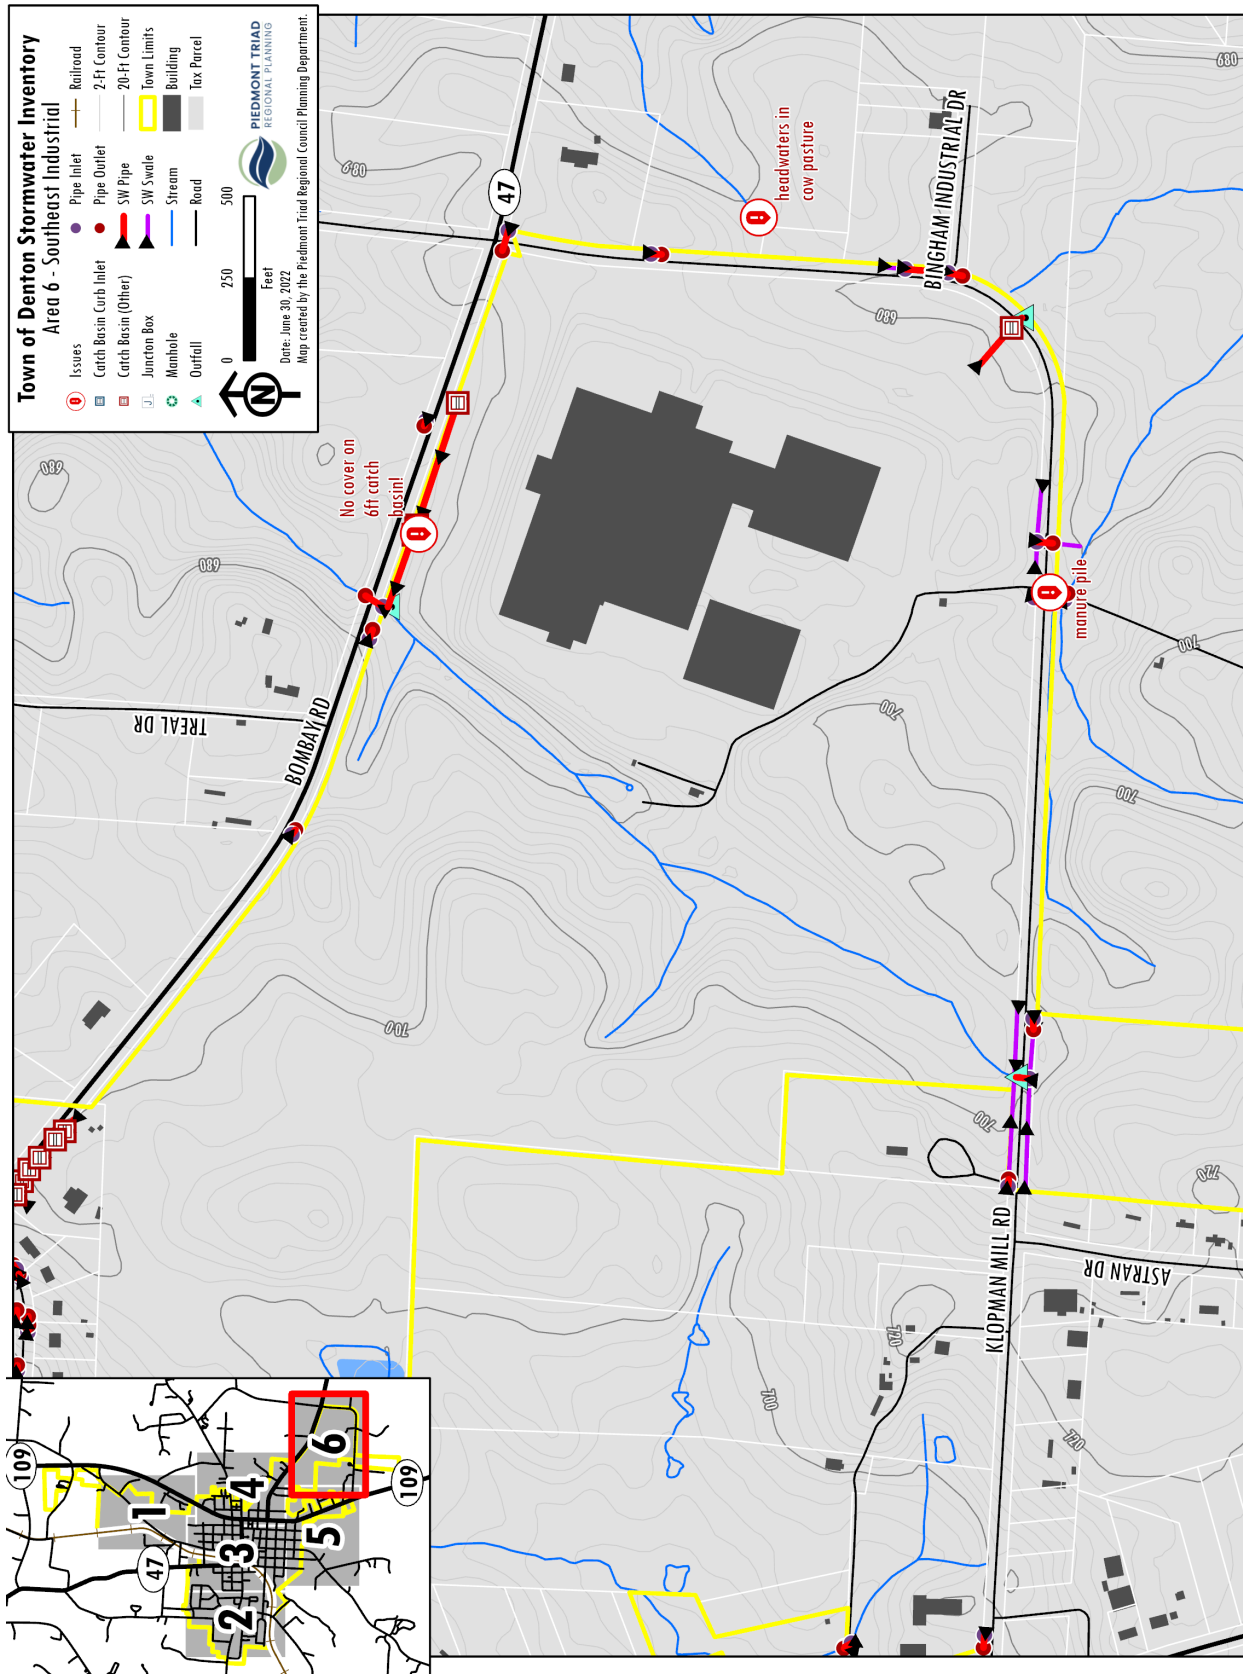
Map 12: Area #6 – Southeast Industrial Area

Stormwater Infrastructure Issues	
Location	Description
Klopman Mill Rd, along eastern edge of town, east of Burlington Industries; south of Bombay Rd. (approx. 410 ft south of Bombay)	Inlet #1326- filled with leaves, woody vegetation, needs cleaning out; Outlet #1298- clogged with woody debris, trash East side of Klopman Mill Rd- is not within town limits, however it is noted that a cow pasture is here at the headwaters of the trib
Health & Safety Issues	
Location	Description
Former Burlington Industries; off Bombay Rd, corner with Klopman Mill Rd	Deep catchbasins (5-feet deep concrete); 2 (#5241, #5235) do NOT have covers over them; 1 has cover over it but it appears moved (#5239)
Off Klopman Mill Rd	Manure pile; across from south entrance of Burlington Industries

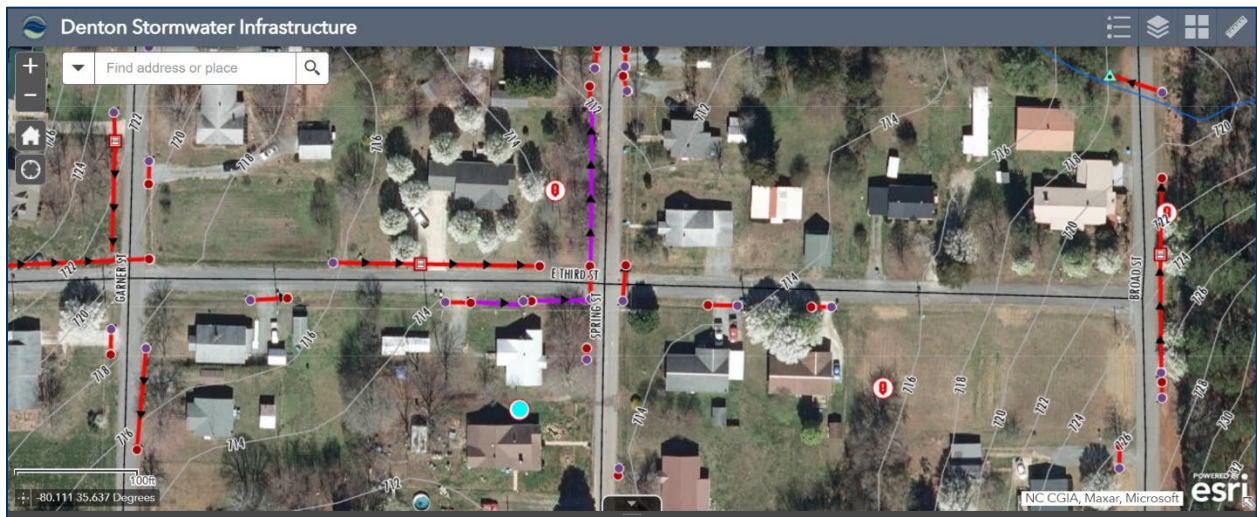
Aerial View of E Third/Spring/Broad Streets

As noted in Area #3, at the intersections of E. Third Street with both Spring St and Broad St, all downhill from NC Hwy 109 there were several areas of concern noted such as issues with standing water. This location could be an ideal candidate for rain garden(s), planting of native trees and/or installation of rain barrels to collect run-off from the area homes. There is evidence of water issues on paved areas/home lots off Spring St, with issues with standing water at E. Third, Spring and Broad St. as well as noted poor drainage. Further investigation for appropriately sized and sited SCMs would help to capture and treat stormwater runoff and prevent standing water/flooding issues. : standing water; broad, Third & spring street (block) (pic on left); (pic on right) issue with poor drainage, standing water in between houses: roadway floods- see wet signature on pavement between houses off Spring St.

Potential Raingarden(s) on E Third and Spring St

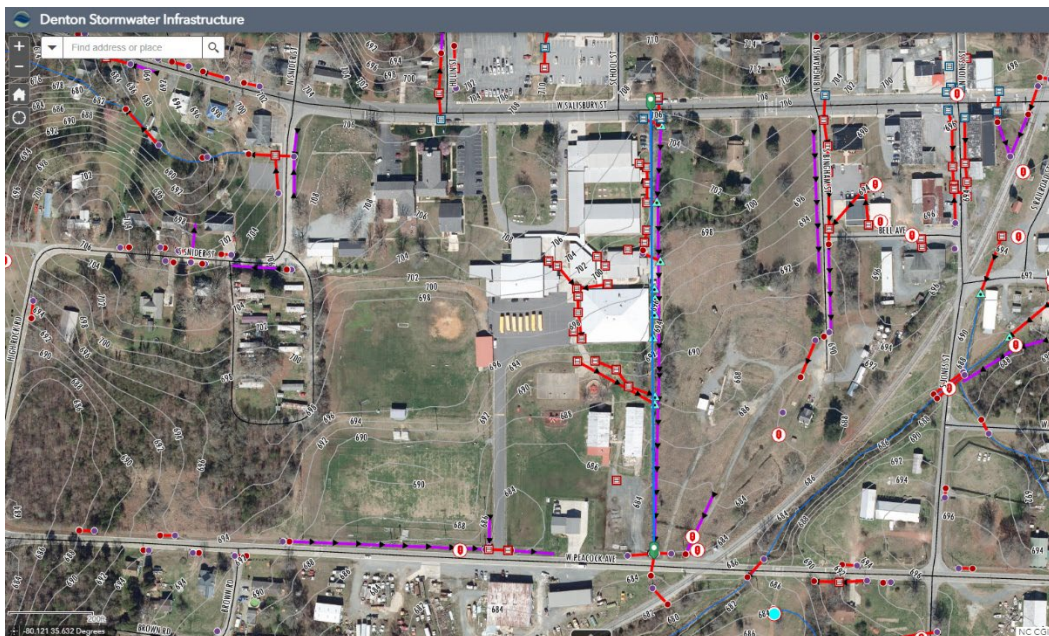
Aerial View of Denton Elementary School

Noted in Area #3, the Denton Elementary School property goes from W. Salisbury Street, main school entrance, and slopes to W. Peacock Ave, back of the school, there is a 1,055 foot long drainage ditch on the school's eastern boundary with ball fields to the west. There are several noted issues dealing with flooding or stormwater along W. Peacock Ave. The property encompasses 17.54 acres. Based on field observations and conversations with the Davidson County Schools maintenance staff that is responsible for the maintenance at the Denton Elementary School, there has been historic flooding issues that have severely impacted the school, buildings and grounds area. It is suggested that further identification of issues of concern be identified and corresponding SCMs or BMPs to best tackle stormwater and flooding be explored with the Davidson County Schools. These type of locations could be ideal opportunities for grant funding as they could incorporate academic opportunities and hands-on applications to address aging or unmet stormwater needs.

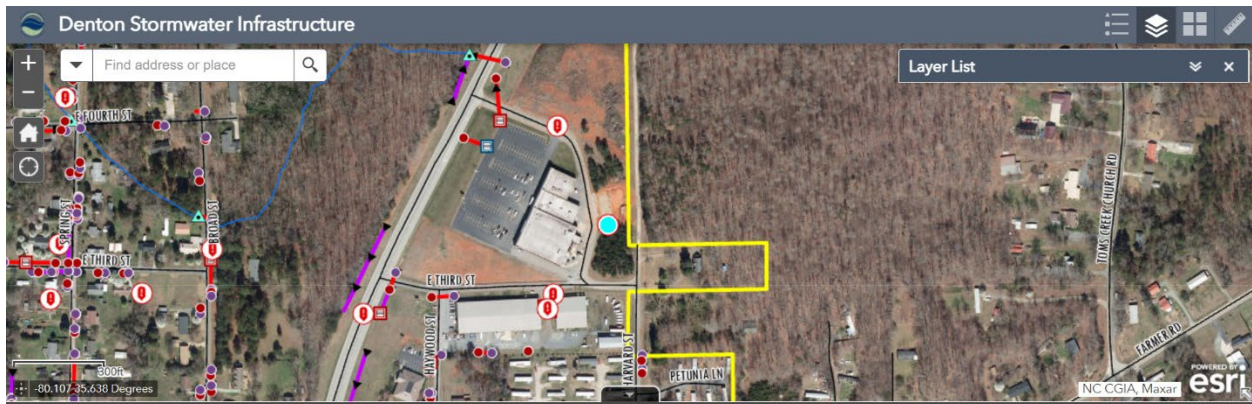
Aerial View of Lowes Foods

As identified in Area #4, at the Lowes Food of NC Hwy 109, there were identified issues with ponding water near and around the shopping center parking lot including areas behind the building as well as areas of concern at the nearby gravel parking area that is across from northern entrance to center. It is noted that pipe outlet #1126 needs repair or replacement. This area should be further inspected to identify areas that can be repaired as well as to identify areas most suitable to implement SCMs. A simple, yet effective practice would be to make sure that all exposed soil is covered in vegetation, it could simply be grasses, however native trees or shrubs would further enhance the infiltration process, reduce uncontrolled runoff and improve aesthetics of the center, both in the front and behind the building.

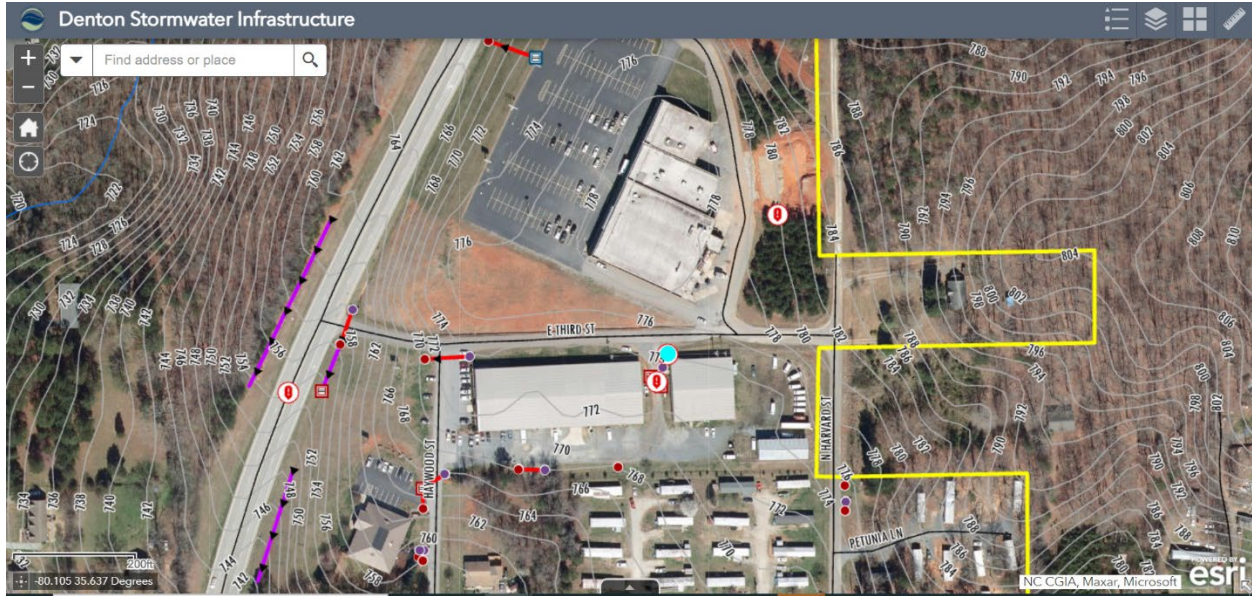
Aerial View of NC Hwy 109/E Third St

As identified during the field visits, noted in Map Area #4, is an area off NC Hwy 109 and E. Third St that has identified flooding as an issue. The commercial buildings have a driveway/access in between a low spot, the elevation goes from 778 ft to 772 ft. There are two catch basins; one inlet, and one outlet- made of PVC. In working with the private business owners, this site could be considered an ideal location to install a linear rain gardens or several smaller rain gardens that would capture runoff from E. Third St before heading down the entrance/access lane, as long as there are no utility conflicts. Additionally, this business could consider capturing the roof-runoff, as well as implementing impervious pavement/pavers in the access/entrance and parking areas in order to better capture and slow the runoff through the site. Additionally, this commercial landowner should work with the landowner of the Lowe's Food in order to properly vegetate the lot such that it could work to infiltrate stormwater as well as reduce excess erosion of the exposed soil.

Vegetated Swales or linear rain gardens are built such that underneath contains porous materials such as rock and/or organic matter to absorb water and native plants are established to help absorb water from the surface. Infiltration is slowed; pollutants absorbed before it reaches a pipe that goes to a sediment pond, river, storm system.
